South Platte River at South Platte Park Lessons Learned

2017 UDFCD Annual Seminar

Troy Thompson, PE
Ecological Resource Consultants, Inc.

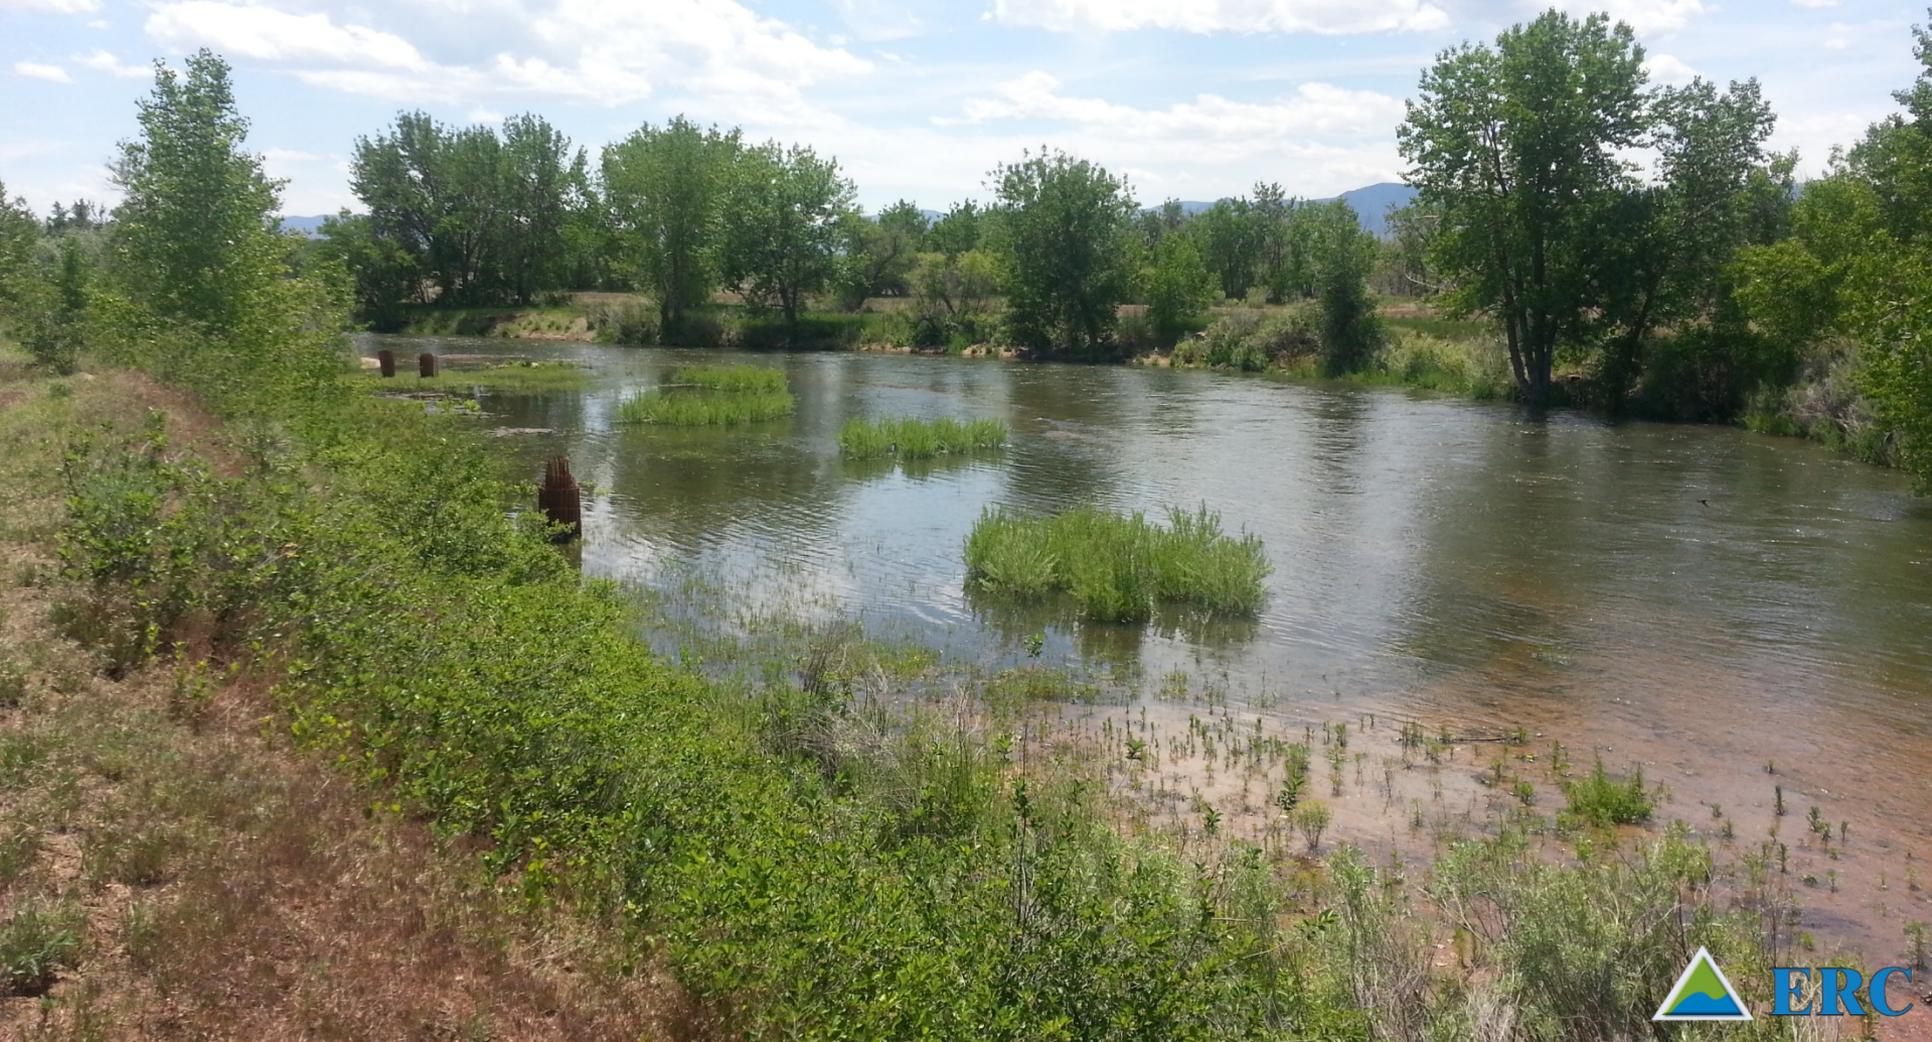
Phase 1: June 2, 2014 - Flows ~ 1,000 cfs

Terrace inundated as designed

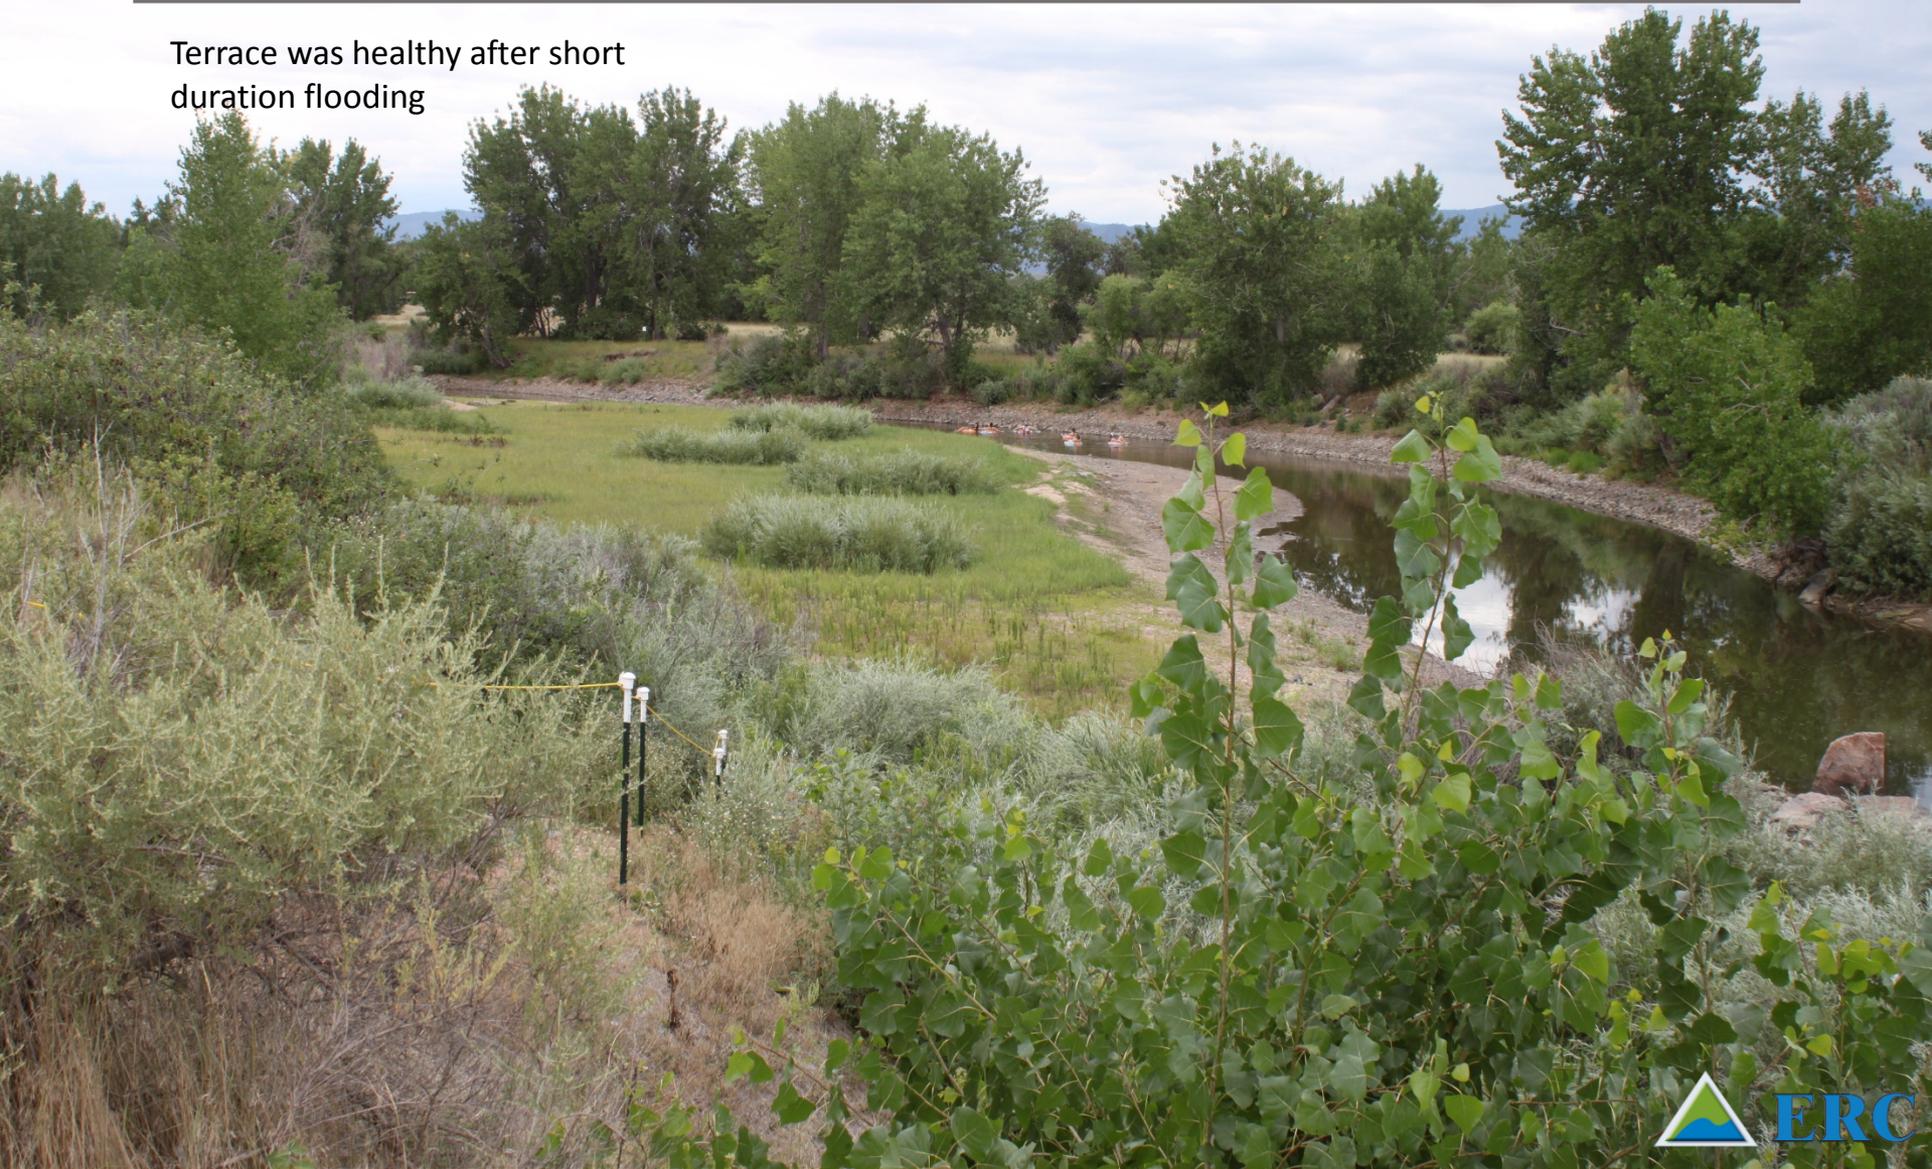
Phase 1: August 1, 2014

Terrace was healthy after short duration flooding

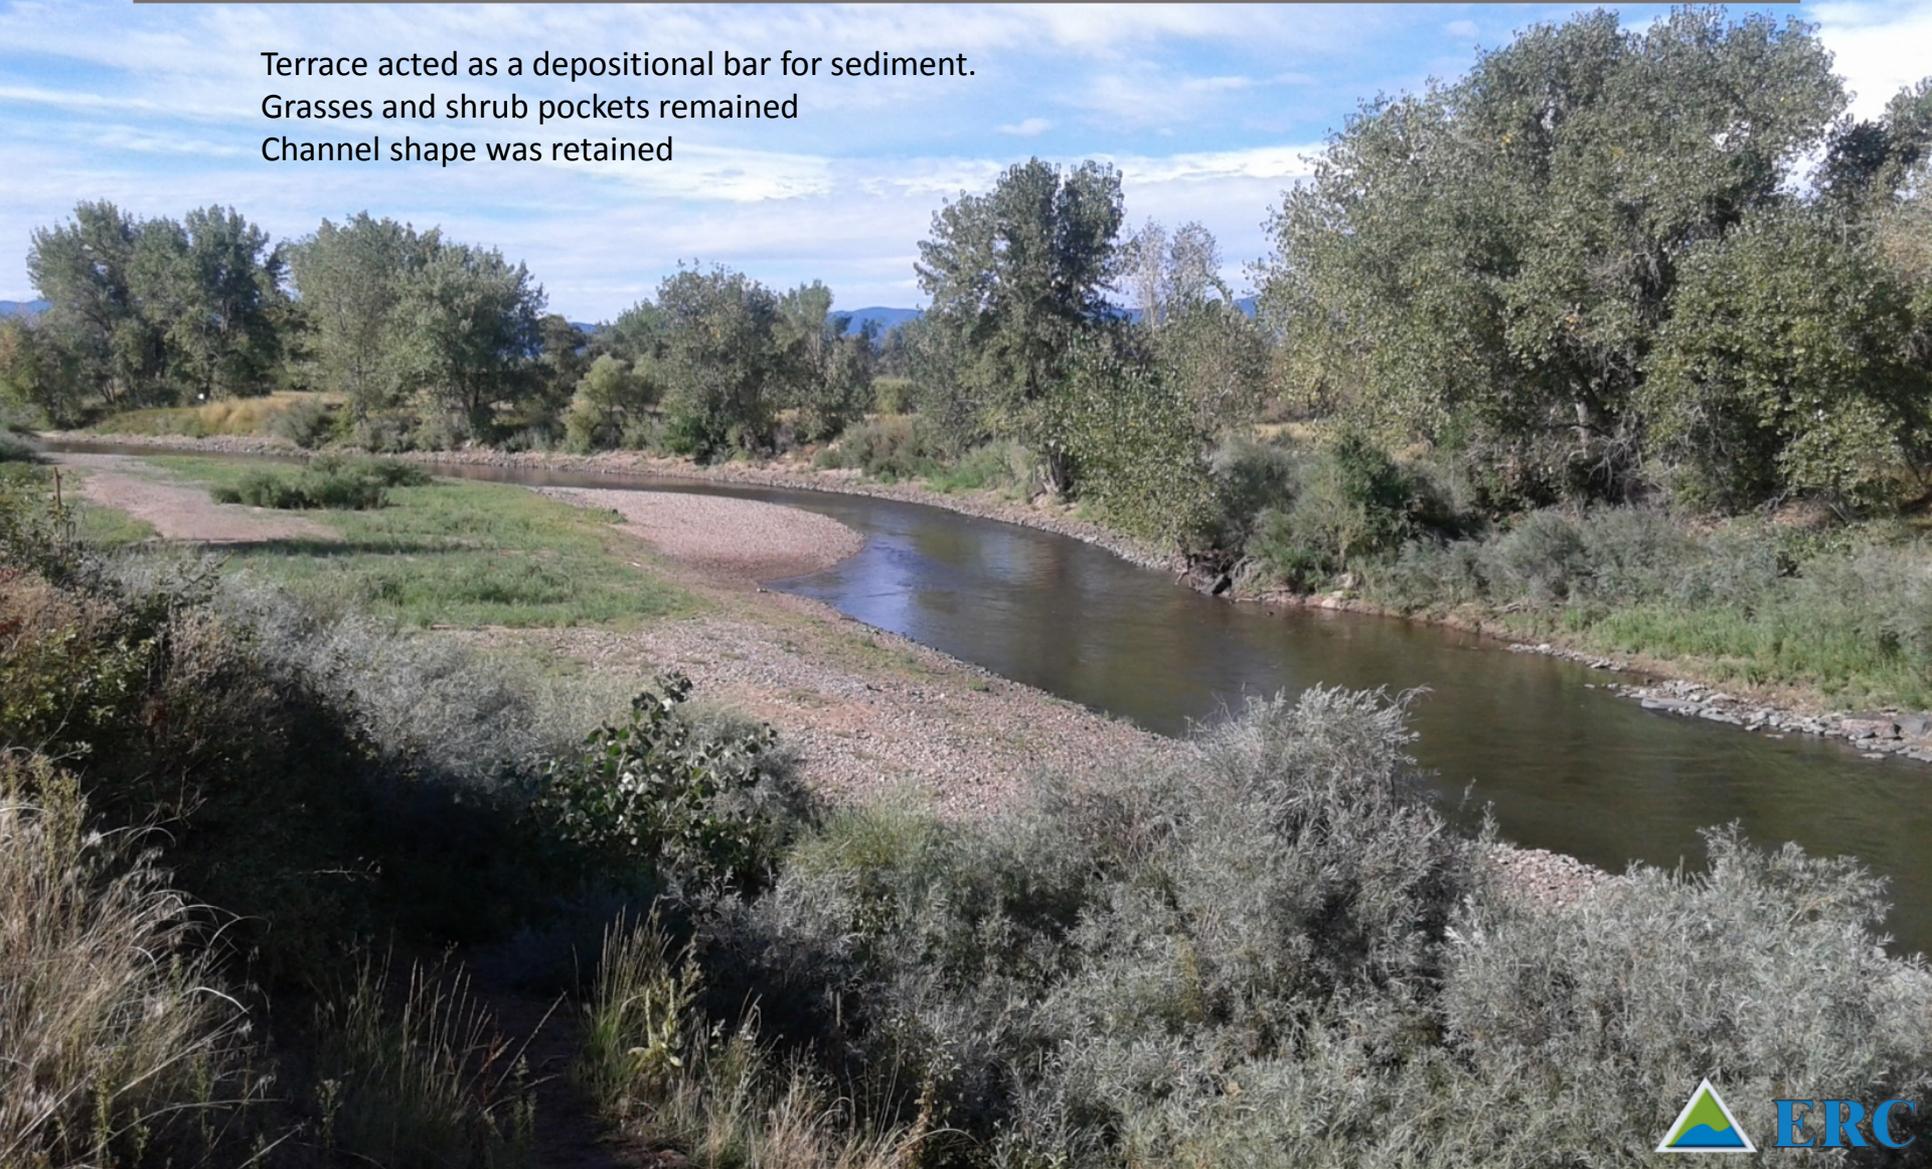
Phase 1: September 4, 2015

Terrace acted as a depositional bar for sediment.
Grasses and shrub pockets remained
Channel shape was retained

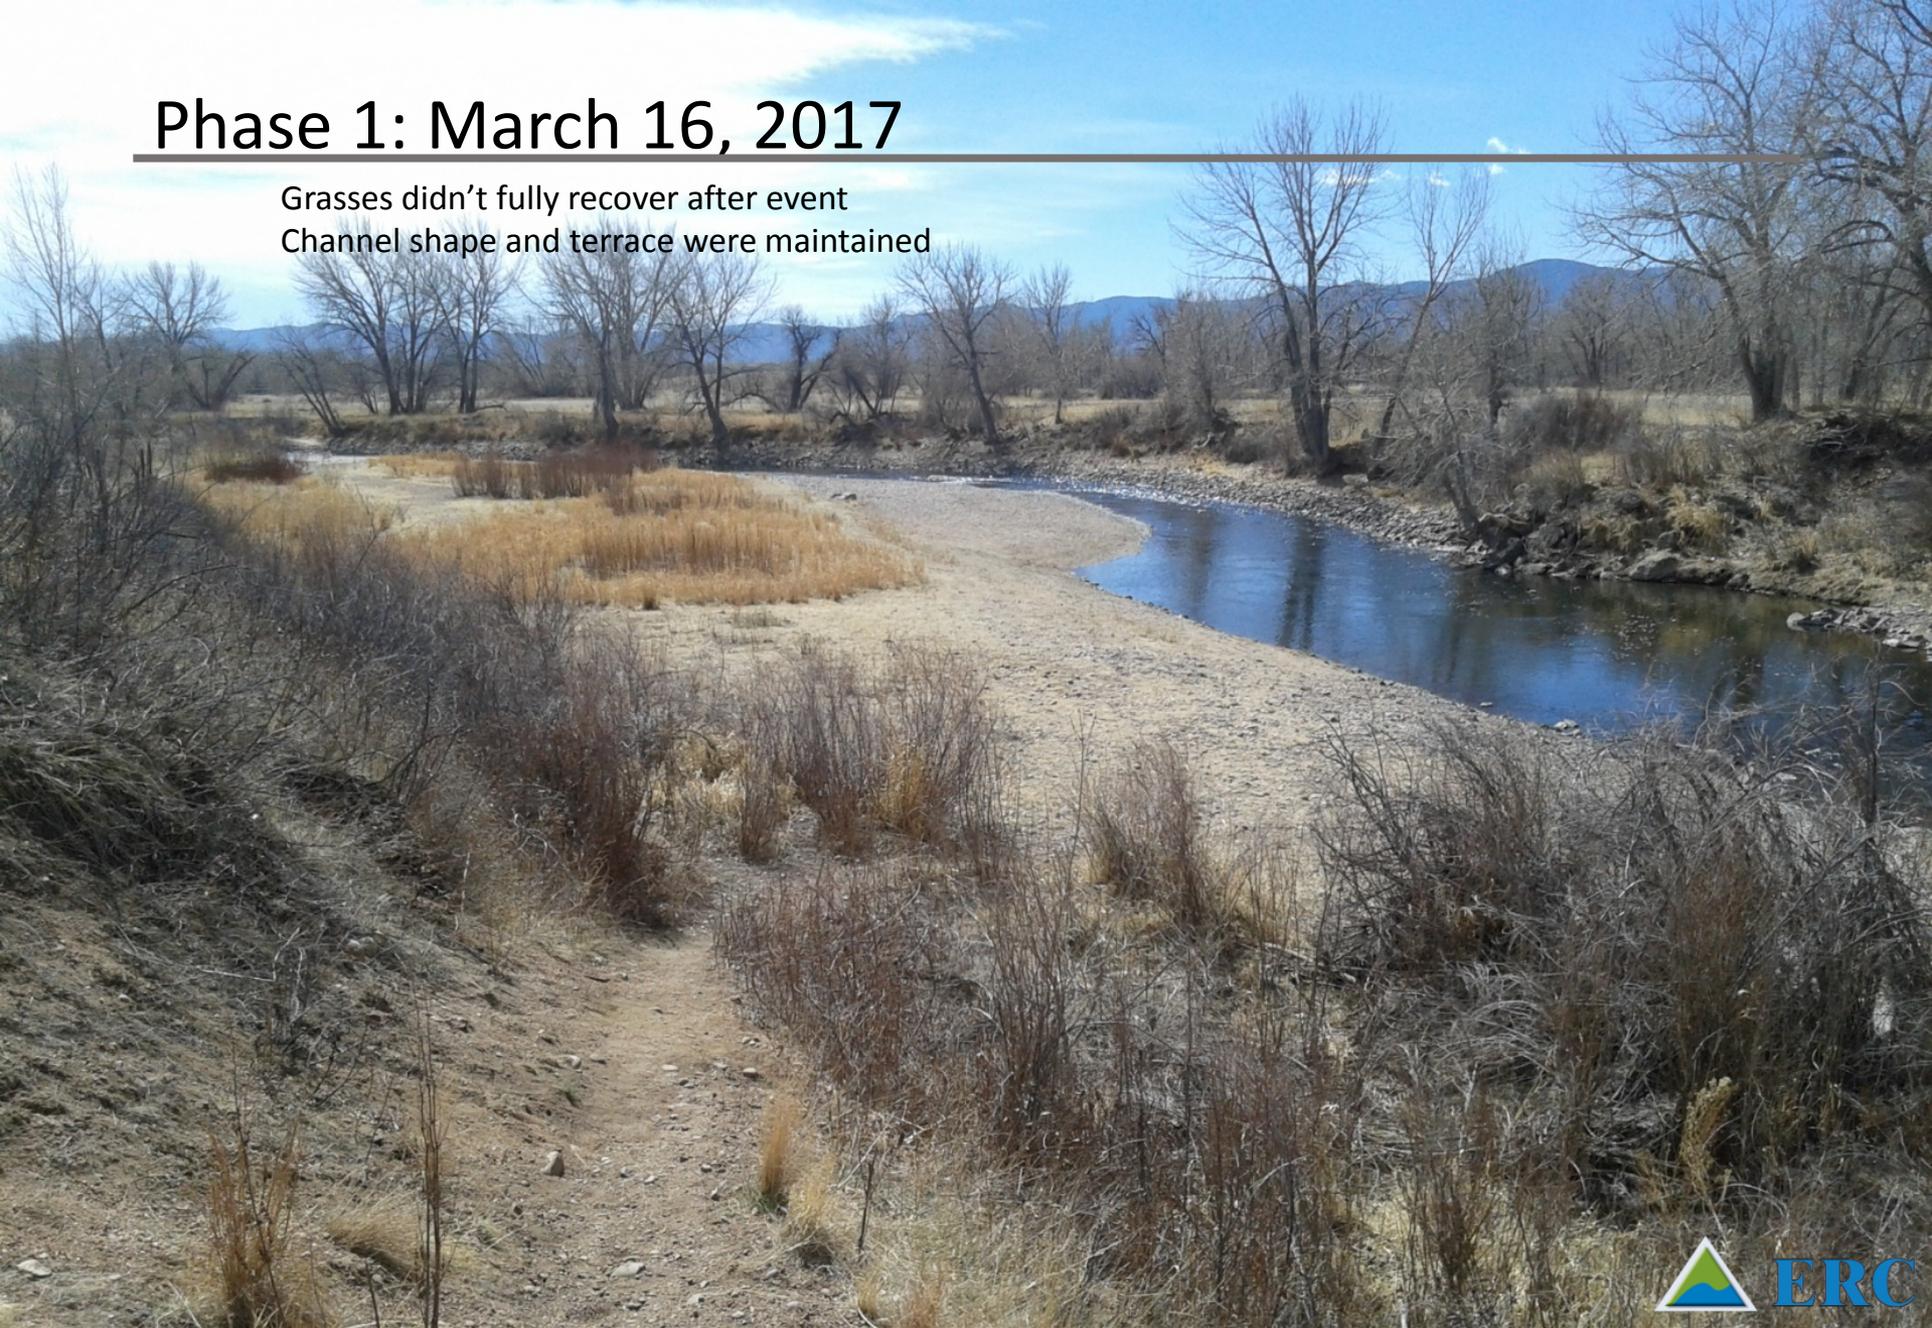
Phase 1: March 16, 2017

Grasses didn't fully recover after event
Channel shape and terrace were maintained

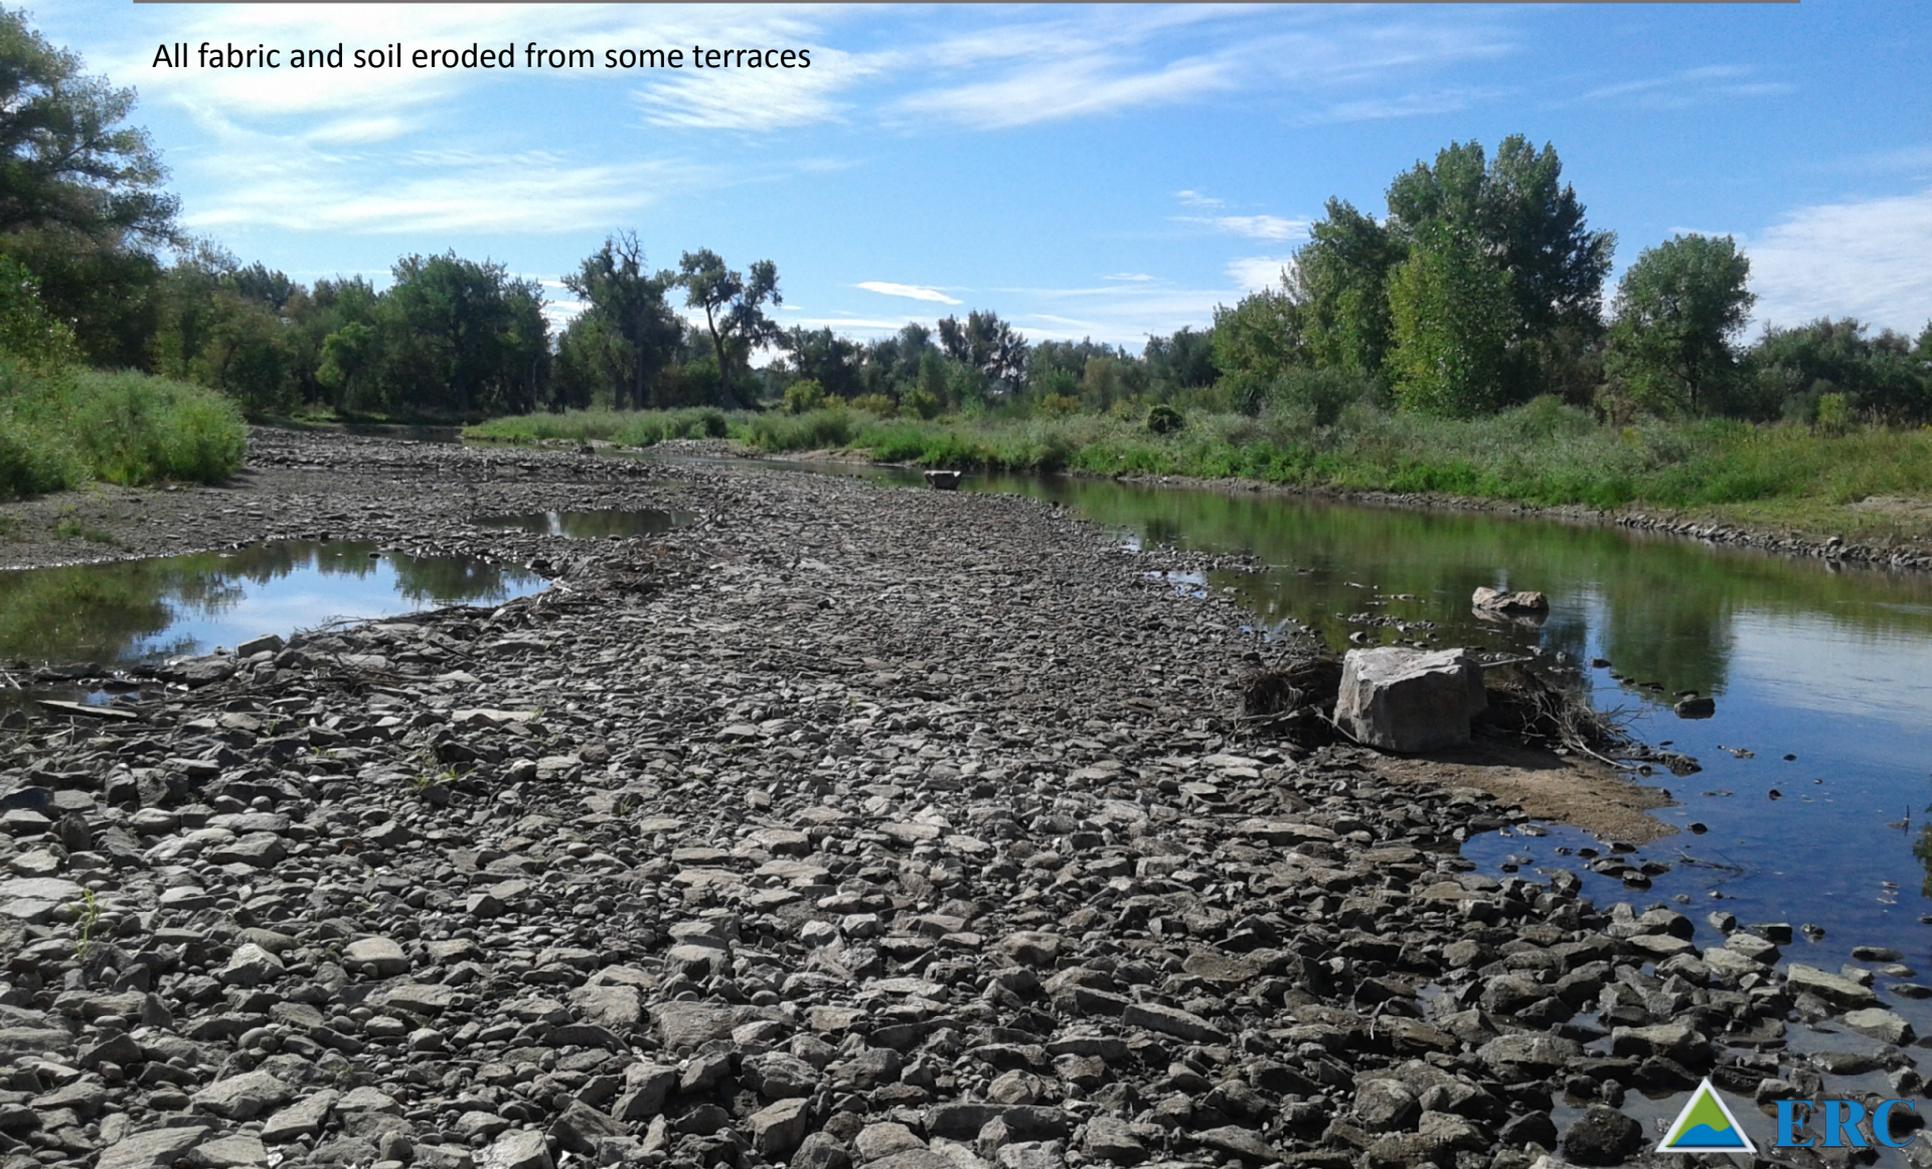
Phase 2: September 4, 2015

All fabric and soil eroded from some terraces

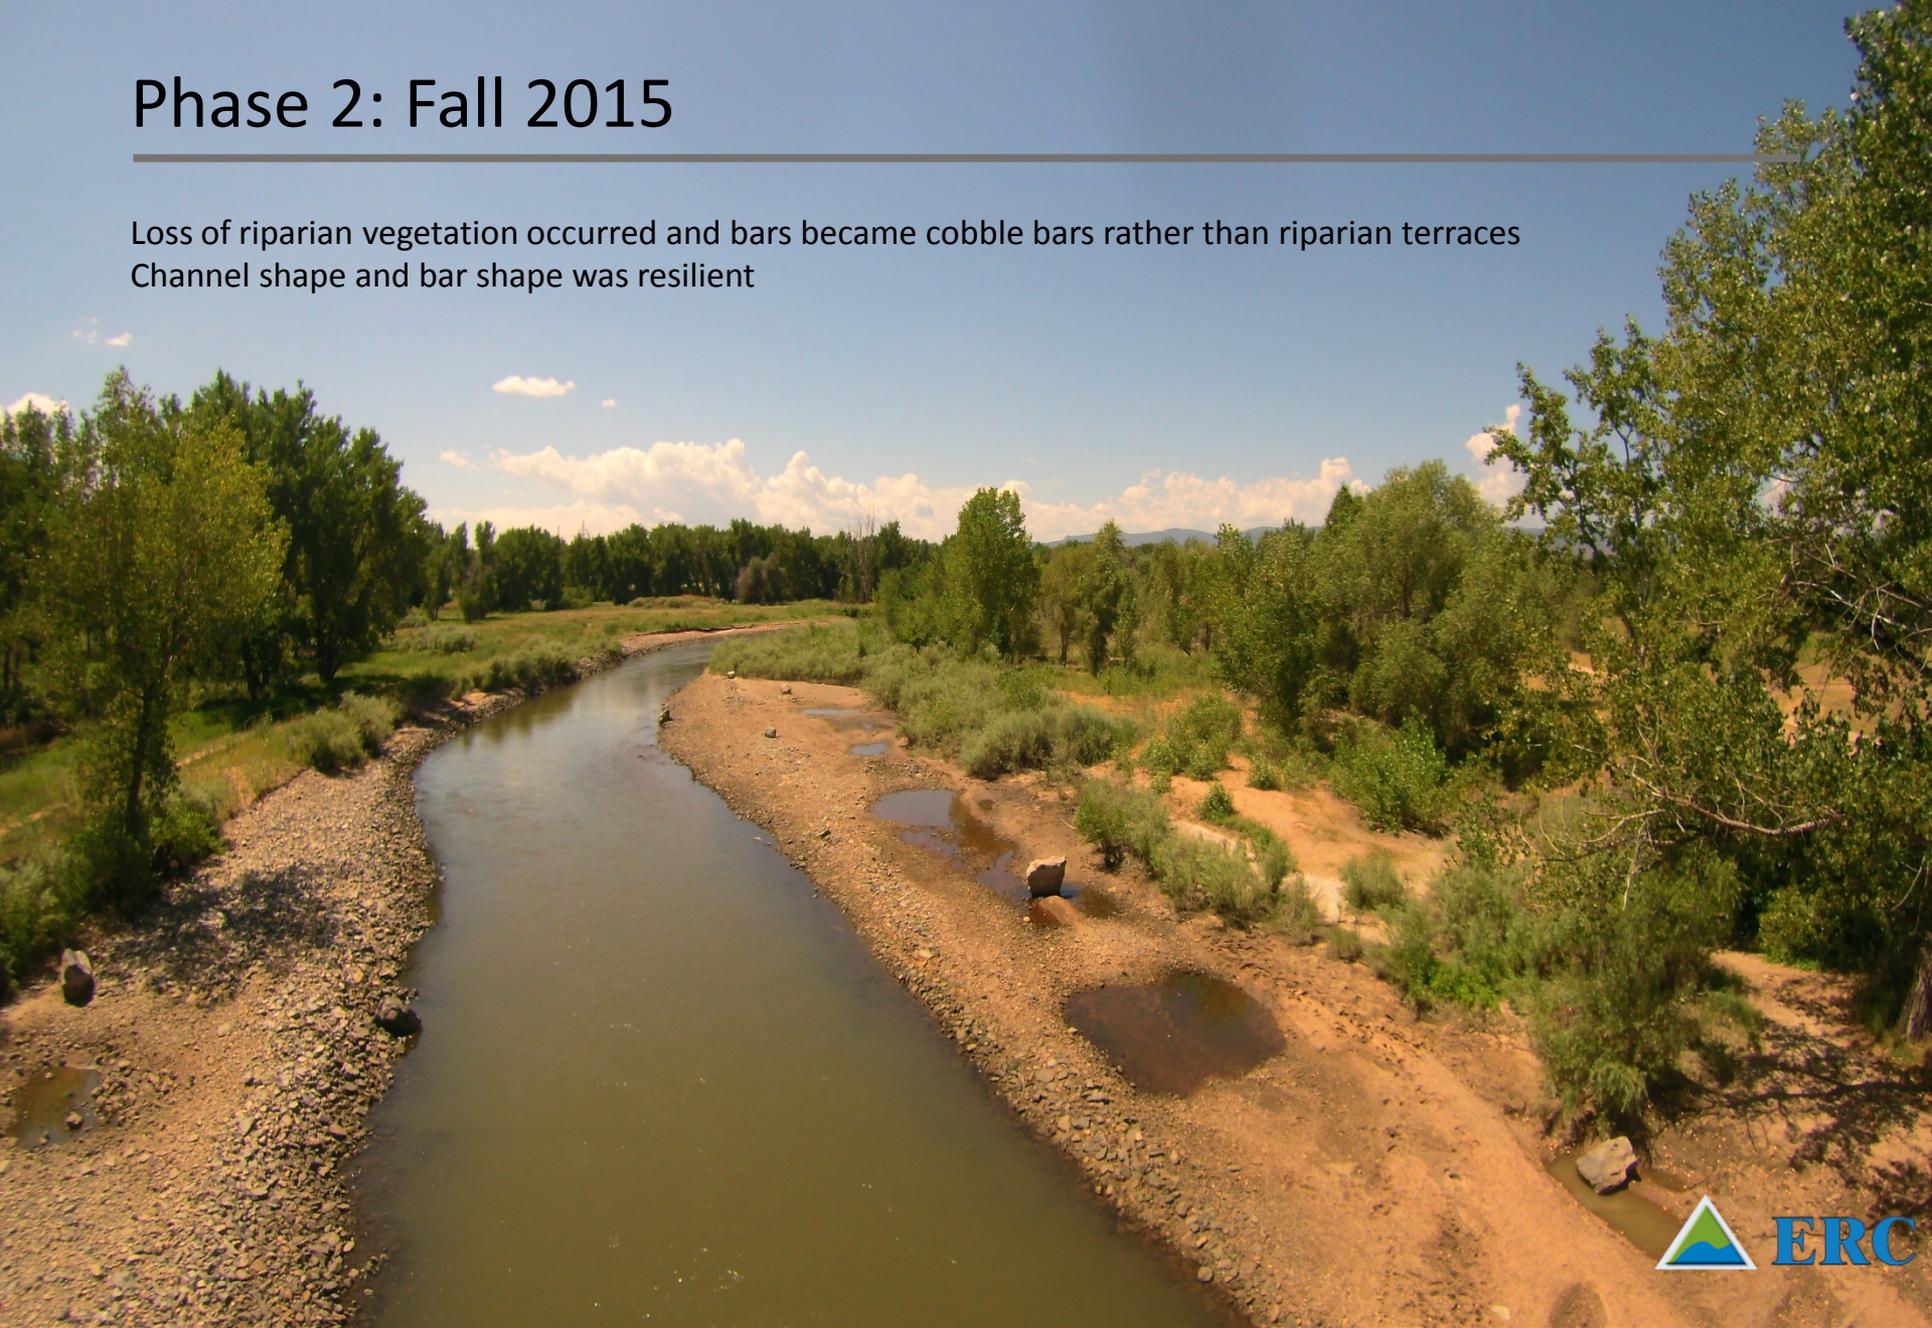
Phase 2: Fall 2015

Loss of riparian vegetation occurred and bars became cobble bars rather than riparian terraces
Channel shape and bar shape was resilient
