South Platte River at South Platte Park Lessons Learned

2017 UDFCD Annual Seminar

Troy Thompson, PE
Ecological Resource Consultants, Inc.

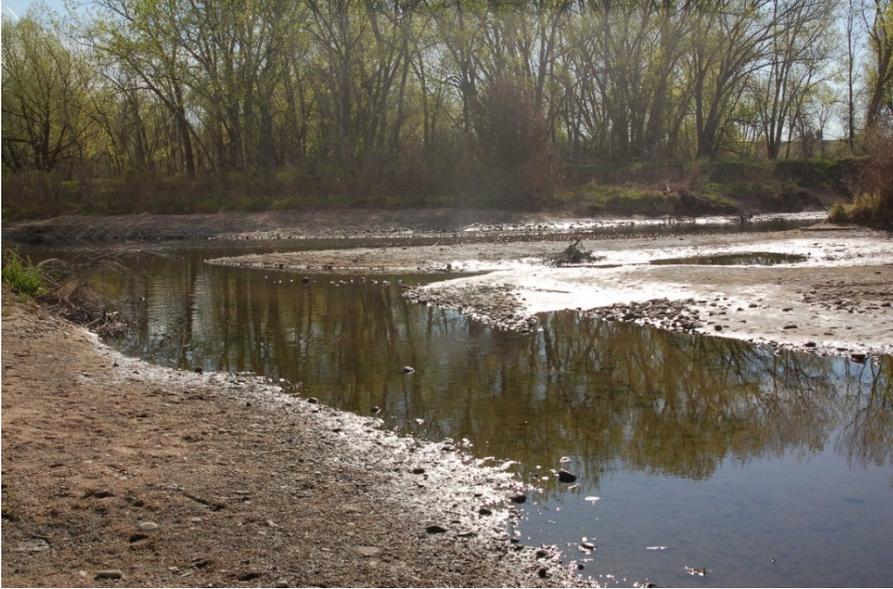
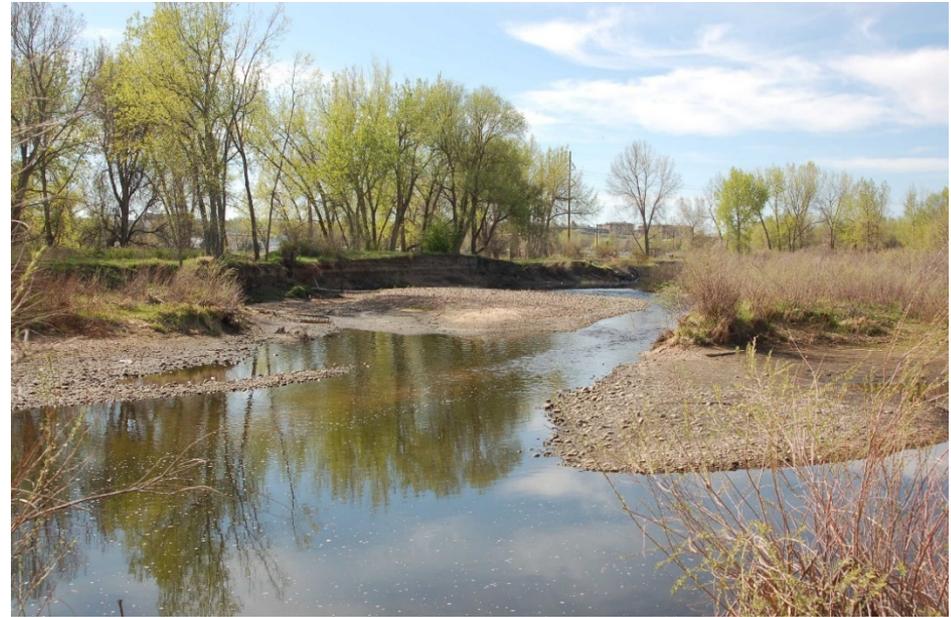
Problem

Channel was Overly Wide For Current Flows

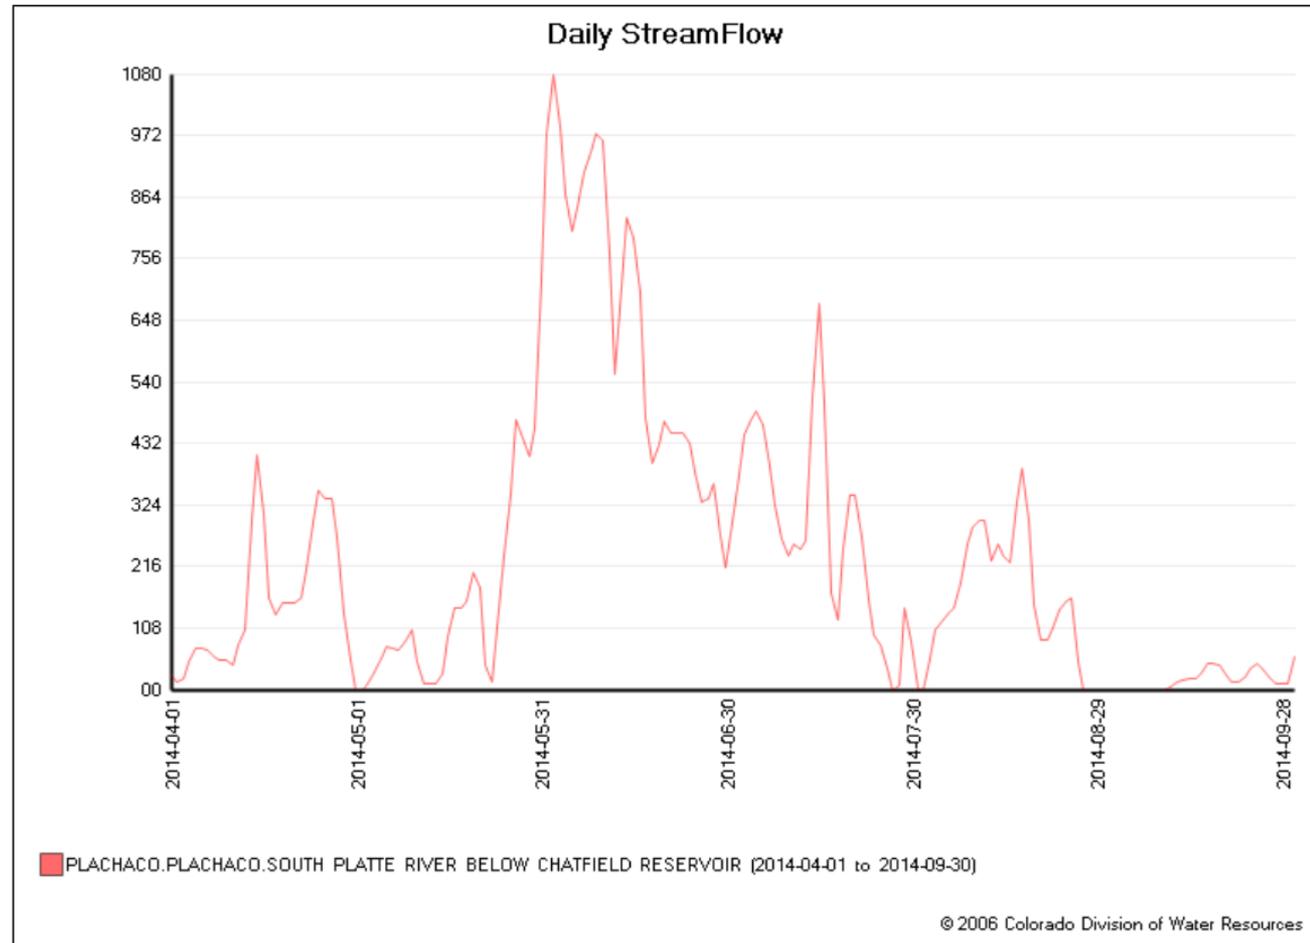
Phase 1: June 2, 2014 - Flows ~ 1,000 cfs

Minor Challenge: High Flows in 2014

Flows were above Bankfull for about 2 weeks

Terrace inundated as designed

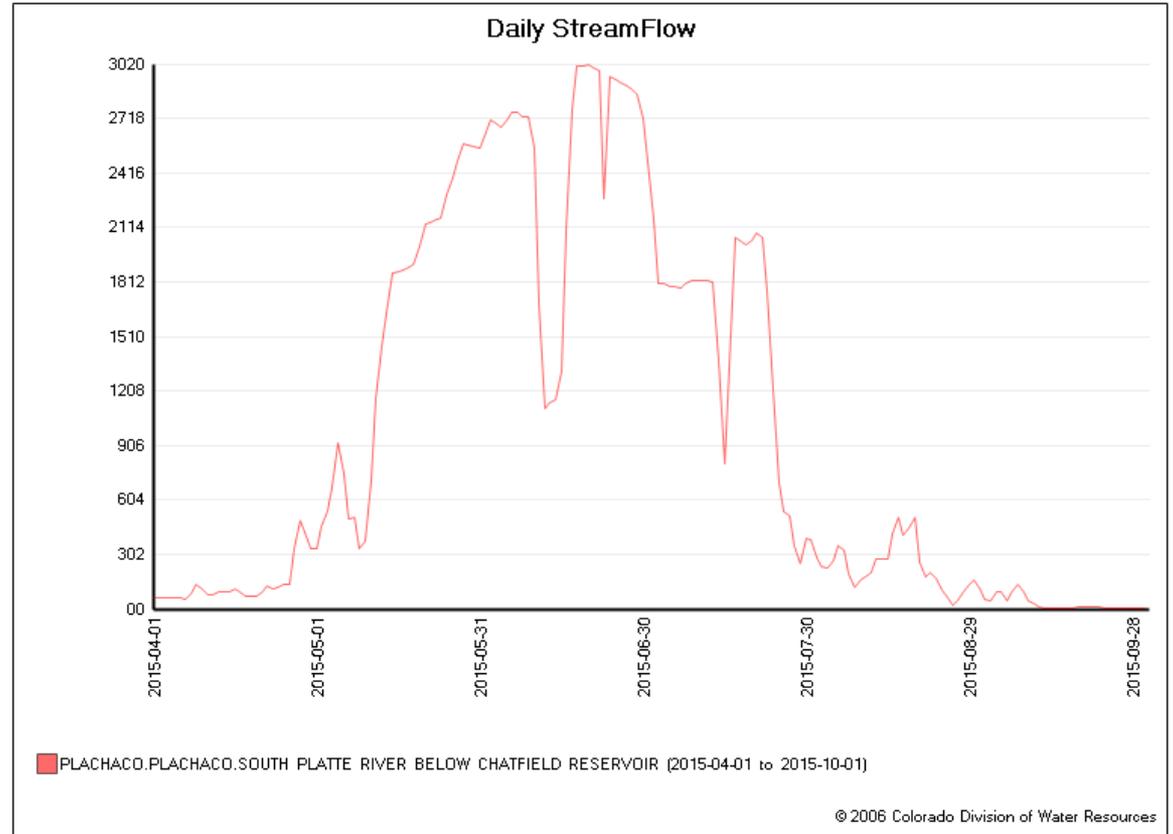
Phase 1: September 4, 2015

Major Challenge: High flows in 2015

Peak Flows over 3,000 cfs

Flows over 1,000 for 2.5 months

Terrace acted as a depositional bar for sediment.
Grasses and shrub pockets remained
Channel shape was retained

- Exposed soil will erode in flood events
 - Timing of work with soils near typical flood levels should likely occur so that grasses can establish over the winter/spring prior to expected peak flows
 - Tight window on fall seeding with potential need for supplemental watering
- Erosion control fabric has some benefits, but likely has weaknesses
 - Quality control is important as construction defects (particularly at edges and overlap areas) allow for system wide unraveling
- Plantings are susceptible
 - Want larger plant material to have time to root prior to flooding
 - Possible staggering of planting to minimize cost exposure
 - Seeding in fall of year zero followed by additional plantings after peak runoff in year 1
 - If project allows, staggering revegetation over several years can reduce risk of loss
