Permeable Interlocking Concrete Pavement (PICP) at Industry in Denver

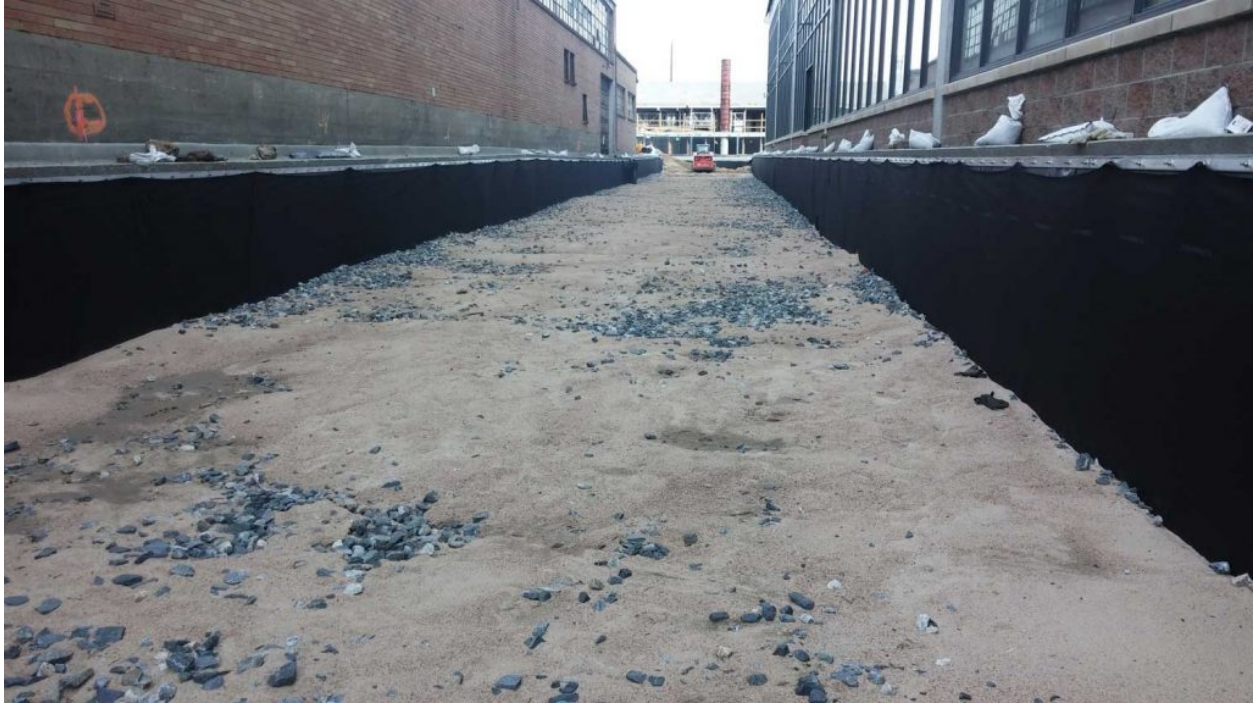
The filter layer in Section 2 was constructed by placing the No. 2 aggregate first and washing in CDOT Class C filter material

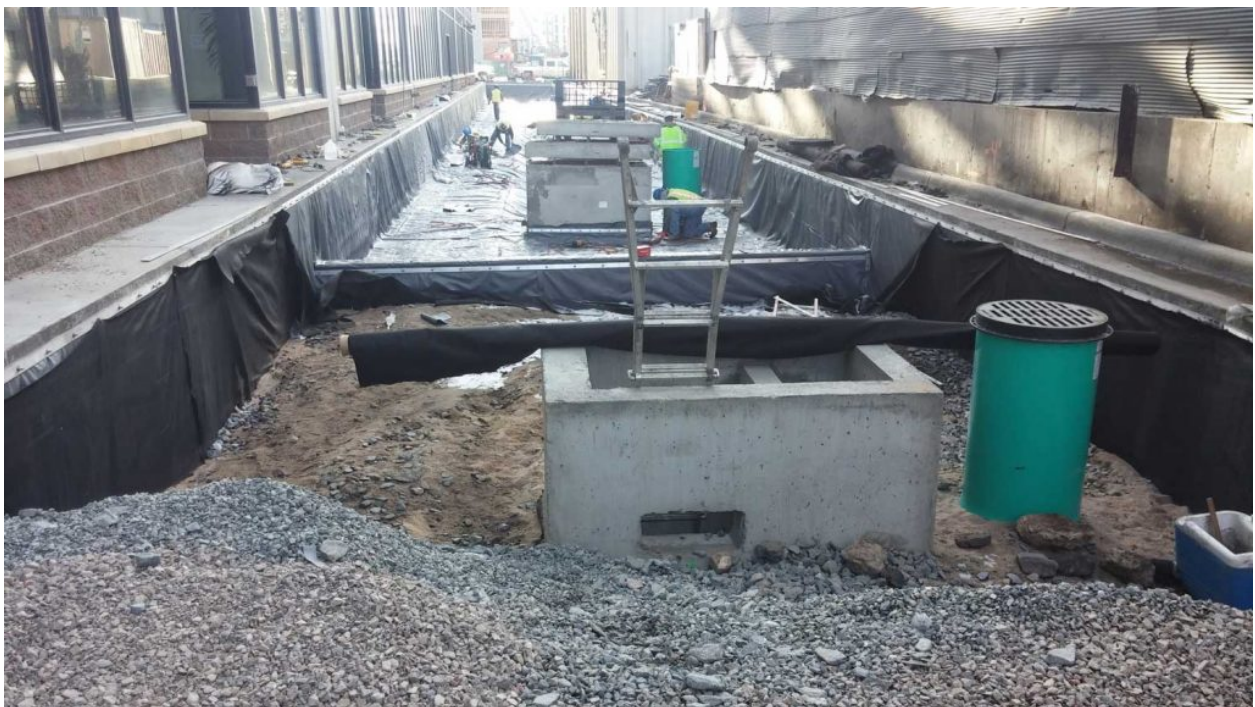
Sections 1 and 2 are separated by a concrete wall

The two sections are separated by a concrete wall at the midpoint of the alley. Composite stormwater effluent samples are collected for both sections as well as for the untreated roof runoff. UDFCD will monitor stormwater quality performance of this system over a period of at least ten years. The District will also collect data regarding maintenance of the site. Maintenance recommendations for PICP are provided at the link below.

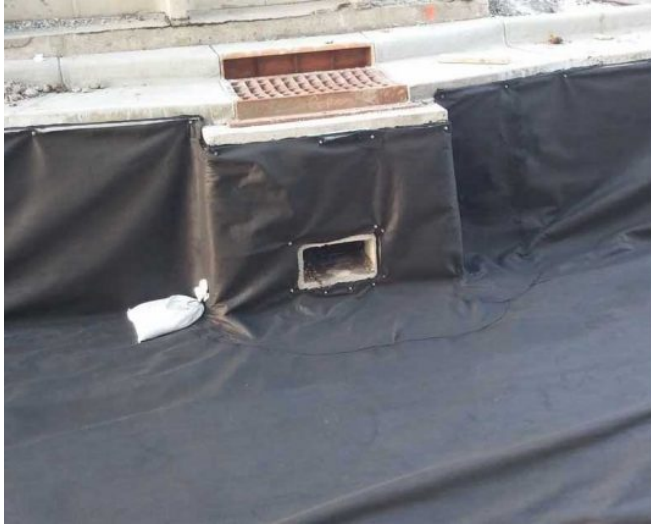
Inlets provide a direct connection to the storage layer which is designed to store the 100-year detention volume. Inlets were designed for pretreatment and filled with an aggregate filter which can be removed and replaced.

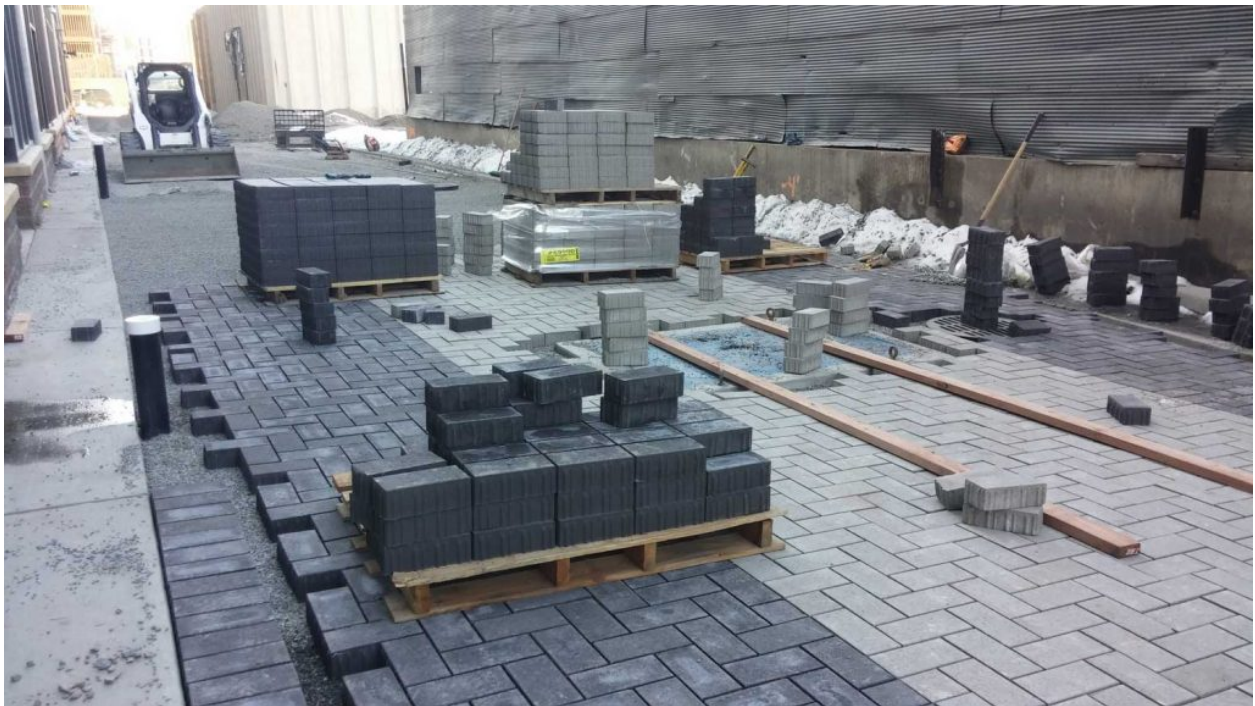
Individual bricks were placed by hand. The bricks have ridges creating openings for stormwater to enter the aggregate section below.

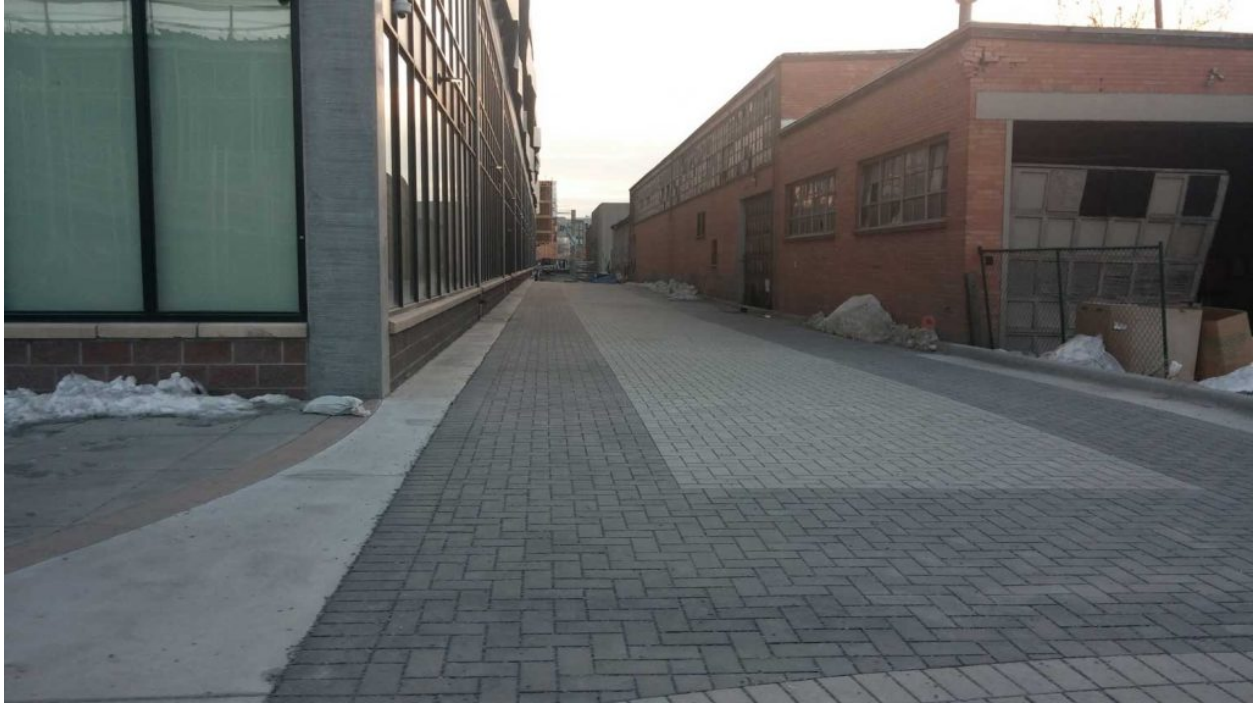
Openings between the bricks are filled with small (No. 89) aggregate. This photo shows Section 1 complete.
